Technical Memorandum to the Record for
Virgin Islands Rum, Industries, Ltd (VIRIL),

Subject: Ambient Ocean Monitoring Survey VIRIL Ocean
Discharge

Revision: November 19, 2003
[Original: November 4, 2003]

U.S Environmental Protection Agency
Region 2

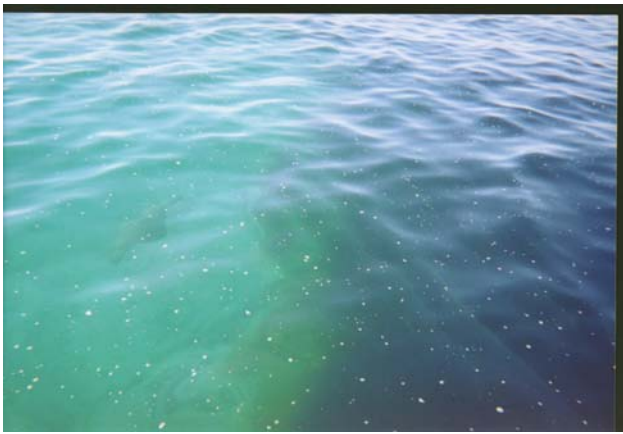
The plume formed a clear edge of delineation between the effluent plume and clearer water adjacent to the plume. Waters outside of the main plume were not turbid and without visible suspended solids and had only a slight green color. This can be easily seen in the Photo Nos. 1 and 2.

Photo 1. The Effluent Plume can be seen on the right of the photo, a sharp edge between the plume and the up current ambient water is visible. Also visible on the left is a green sea turtle underwater swimming towards the plume.

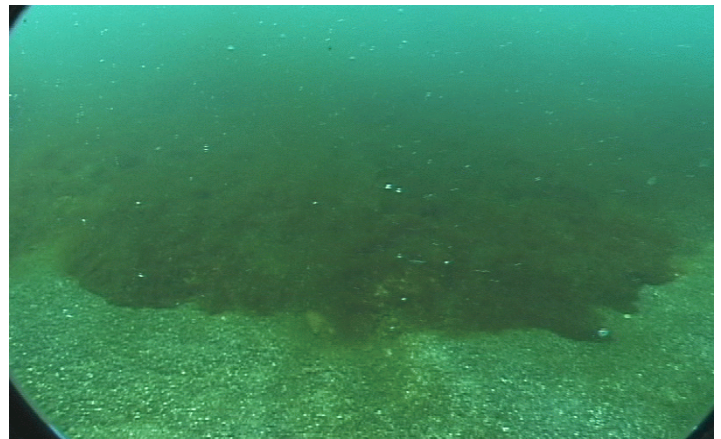
In the immediate vicinity of the outfall, small bubbles were also observed rising to the surface. This phenomena was observed by EPA divers and recorded by the divers on video tape, which indicated that the bubbles appeared to originate in the sediment and may be associated with septic (i.e., anaerobic) conditions in the benthos due to low dissolved oxygen.

Photo 2. Underwater view of the edge of the immediate vicinity plume. Also visible in the foreground is gas emanating from the sand bottom.

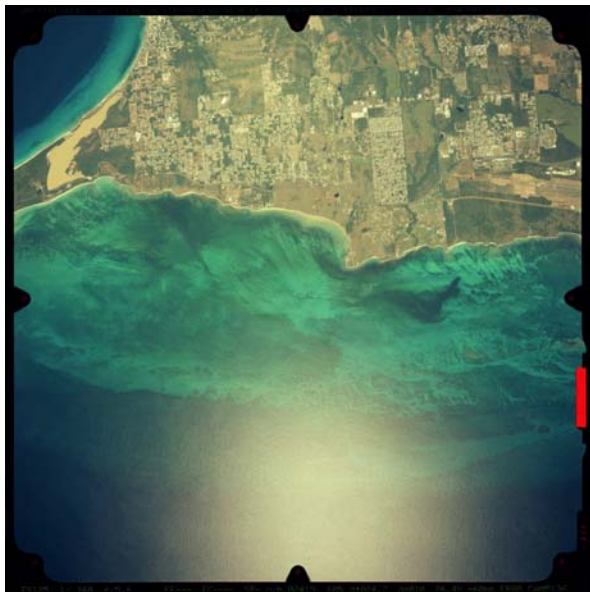
The near field plume is characterized by being just beyond the zone of immediate impact in the vicinity of the outfall but still with a visible band of floc characterized by turbidity and dense suspended, colloidal or settleable solids in the lower depths. A secchi disk placed in the near field plume is generally clearly visible until it enters the bottom 1 meter of water depth where it quickly disappears. This subsurface plume is visible in the following ariel photographs from NOAA.

Photo 3a VIRIL Effluent Plume as seen from high altitude aerial photography by NOAA. The visible subsurface bottom plume of floc characterized by turbidity and dense suspended, colloidal or settleable solids is visible as a black band in each picture. The color plume described in the report is not visible at this altitudes. [Top is north]

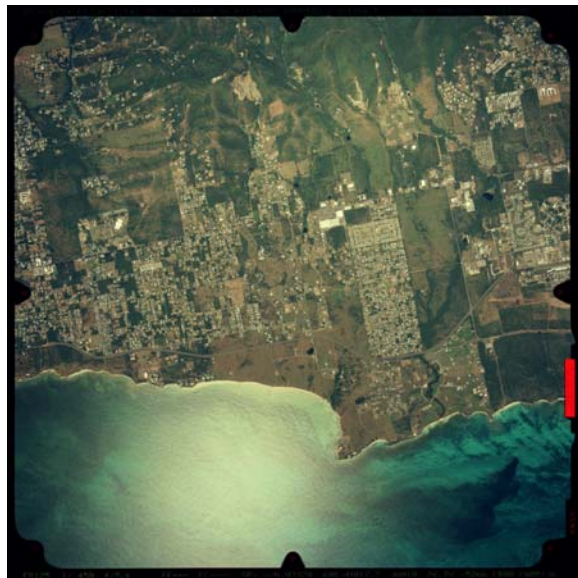
Photo 3b VIRIL Effluent Plume as seen from high altitude aerial photography by NOAA.

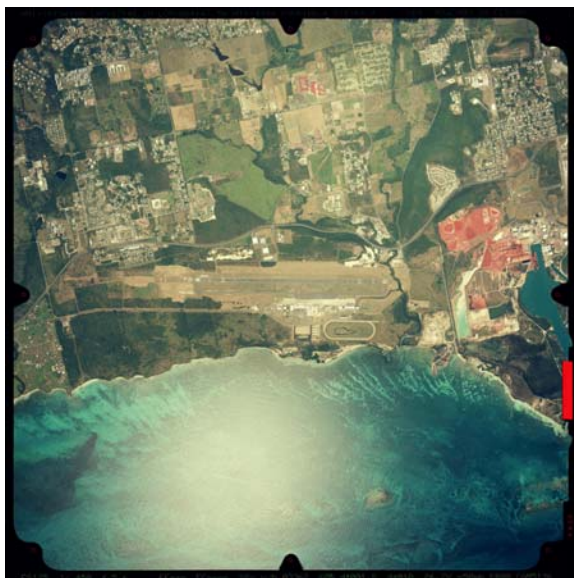
Photo 4 VIRIL Effluent Plume as seen from high altitude aerial photography by NOAA. Plume is visible in the bottom left. The red area on the right is bauxite ore at Virgin Islands Aluminum Co.

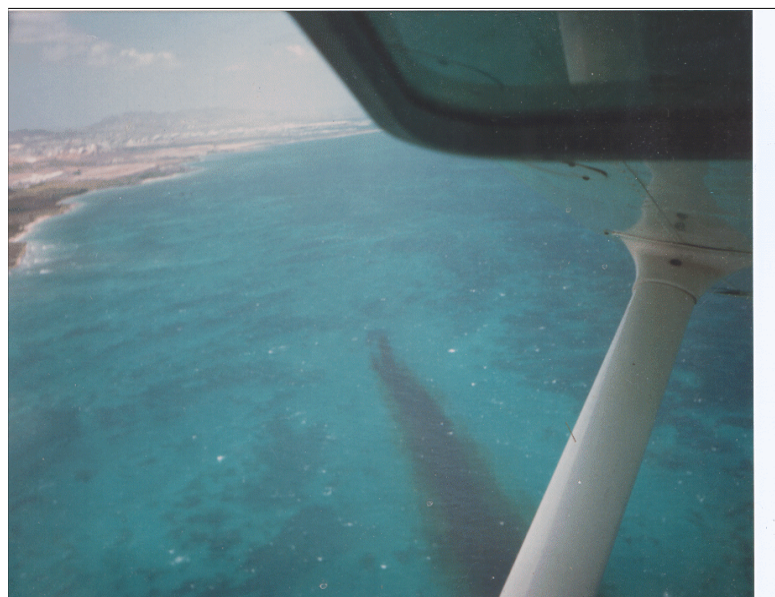
Photo 5 VIRIL Effluent Plume as seen from inside aircraft. Photo is courtesy of Jeff Miller, formerly of DPNR. Date of photo is unknown.

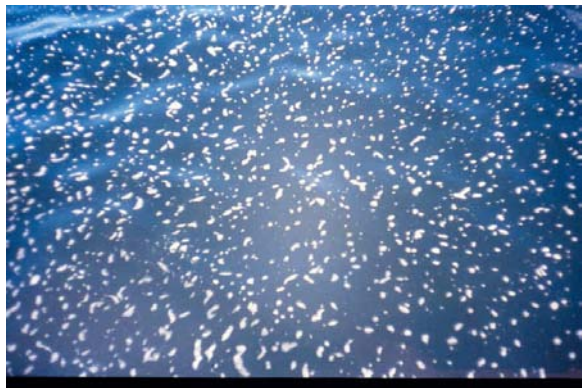
In the immediate vicinity of the outfall, foam was visible floating on the water; this foam was similar, though less in quantity to foam observed at the VIRIL fermentation tanks.

Photo 6 Surface Foam in the area of the immediate vicinity of the outfall.

The Virgin Islands Water Quality Standard for oil and floating substances requires that there shall be “no residue attributable to wastewater nor visible oil film nor globules of grease.” There was no visible oil film nor globules of grease present during the inspection, however, as described above, a significant amount of foam was observed in the immediate vicinity of the outfall (see Photo No. 6). This foam was similar in appearance to the foam that was observed in the fermentors at the VIRIL facility during the inspection (see part I.D.ii above). This foam is a residue attributable to the wastewater that forms a floating substance. This discharge is therefore in

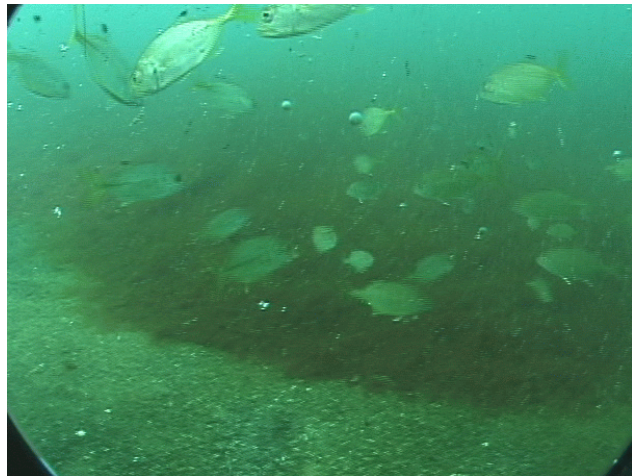
Photos 8a. Schooling fish swim about and within the immediate vicinity plume.

Photos 8b. Schooling fish swim about and within the immediate vicinity plume.

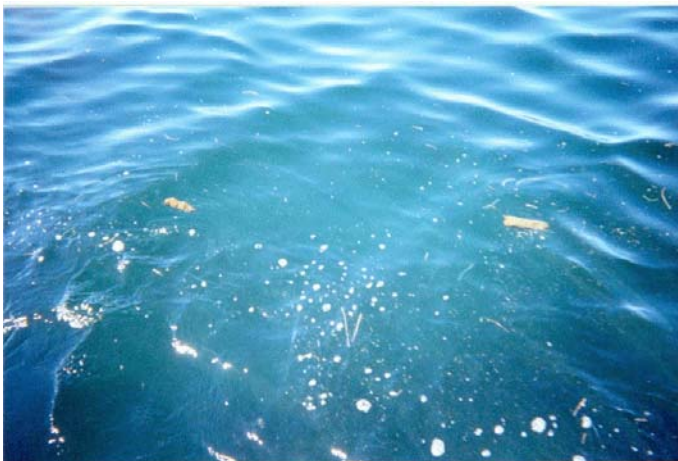
- K. During the survey, a number of “floaters” were observed. These “floaters” were observed by all of EPA survey personnel and each determined, based on their visual observations that these were likely to be human feces. See Photo No. 9 for photo of suspected human feces. The total number of “floaters” observed was approximately 30, with an approximately equal numbers of suspected human feces being observed each day of the survey. No “floaters” were taken for bacteriological or other analysis during the survey. Some “floaters” were observed in the VIRIL plume while others were observed outside the plume, including up current of the VIRIL outfall. This, combined with the fact that the Compliance Evaluation Inspection did not reveal any known sources of sewage entering the VIRIL outfall, and the VIRIL discharge system includes a pressurized force main that would likely macerate any human sewage, and that a pressurized line is not

Photo 9 Suspected Human Feces.

prone to illegal connection leads to a conclusion that VIRIL is not the source of the suspected human feces. The area on the south shore of St. Croix should be investigated for the source of the floaters.
